Medical Safety Information

Pharmaceuticals and Medical Devices Agency

pmda No. 26 September 2011

Precautions for Magnetic Resonance Imaging (MRI) Scans (Part 2)

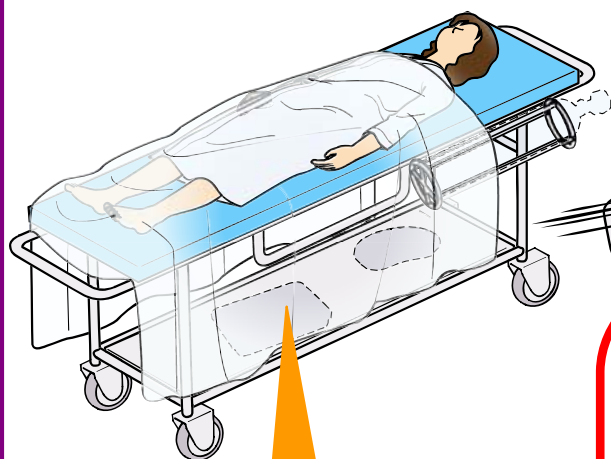
(Case 1) When a patient was transferred to the MRI room on MRI stretcher for an MRI scan, an oxygen cylinder beside the stretcher was swiftly pulled towards the gantry, where it stuck.

- Make sure that there are no magnetic objects before entering MRI room.

MRI room has a strong magnetic field at all times, and it is strictly prohibited to bring magnetic objects into MRI room.

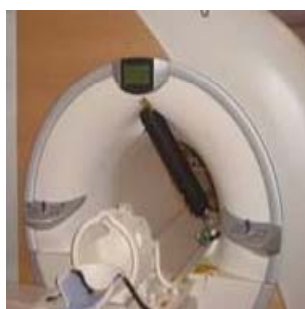
Oxygen cylinder

There have been reports of accidents where patients or healthcare professionals were injured by being hit by flying magnetic objects such as oxygen cylinders or stretchers.
