# PMDA

## Medical Safety Information

**pmda** Extra issue No. 3 March 2022

### Reminder Series No. 3 (Precautions for Magnetic Resonance Imaging (MRI) Scans)

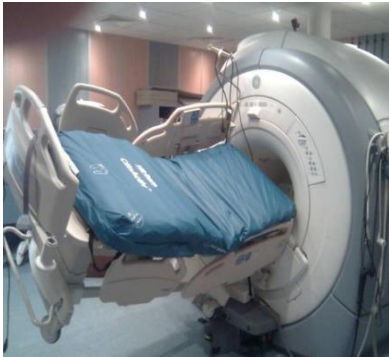
Bed

**There have been reports of accidents where patients or healthcare professionals were injured by being hit by flying magnetic objects such as oxygen cylinders or stretchers.**

See the checklist before entering an MRI room.

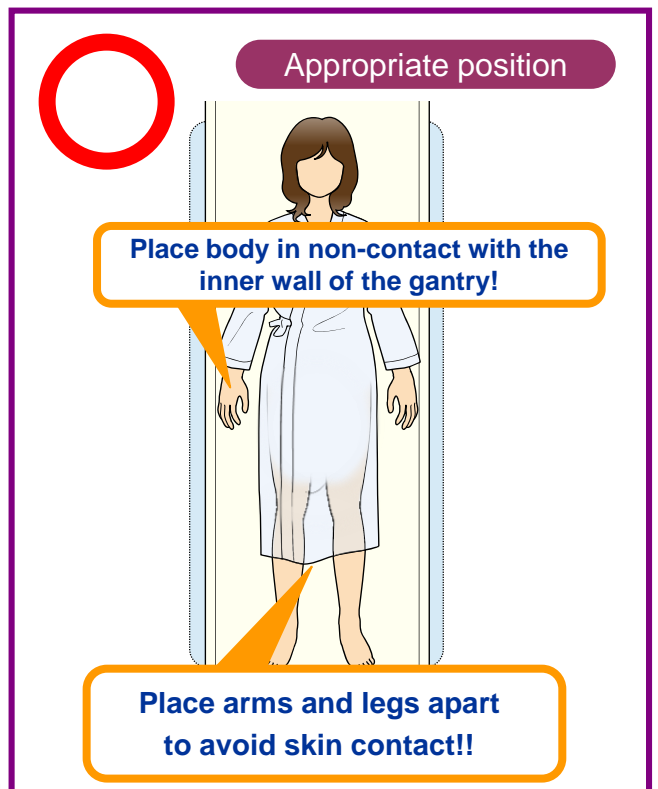
**(Case 4)** A patient received a burn (Degree I-II) on the inside of the thigh after having an MRI scan. Contact of the insides of the thighs during the MRI scan may contribute to forming electrically conductive loops.

There is a risk of burns at the point of contact due to induced current, which is caused by skin contact or contact with the inner wall of the gantry during MRI scans.

- Make sure that there is no skin contact in the patients' arms and legs at positioning.
- Provide patients with clear instructions not to move (change their body position) while being scanned in the MRI machine.
