## **Pinda** No. 61 March 2022

Failure to Break Separation of Two-chamber Bag Preparations (Bag-type Kit Preparations)

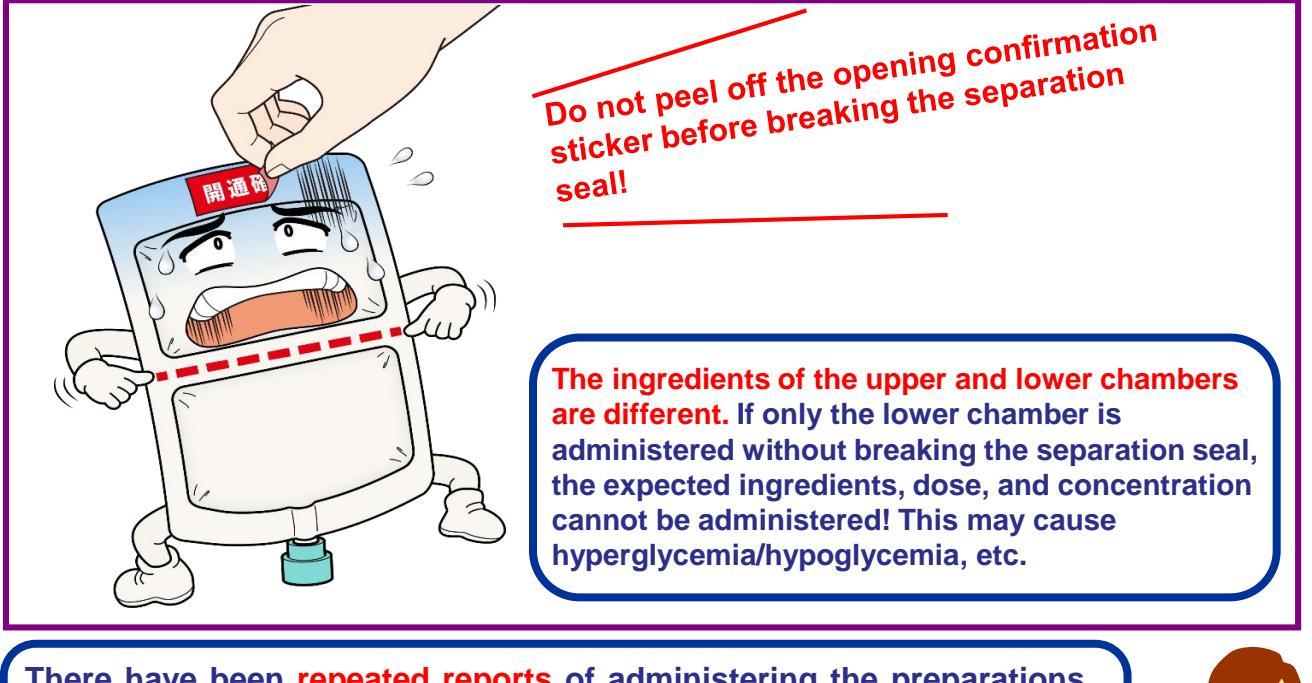
Failure to break the separation seal of two-chamber bag preparations

- Two-chamber bag preparations require breaking the separation seal before use.
- Do not remove the opening confirmation sticker or tag before confirming that the separation seal is broken.
  - \* In some products which have built-in mechanisms to prevent administration while the separation seal is unopened, there may be no sticker or tag to confirm that the separation seal is broken.
- (Case 1) When mixing an infusion preparation, the red opening confirmation tag was unintentionally removed before breaking the separation seal, and the procedure was interrupted for another task. When resuming, the medical staff took it for granted that the separation seal of the preparation had been opened because the confirmation tag had been removed, and it was administered without breaking the separation seal.

There have been repeated reports of administering the preparations without breaking the separation seal of the two-chamber bag. Make sure to follow the opening method and the procedures of opening confirmation. Medical Safety Information Pharmaceuticals and Medical Devices Agency https://www.pmda.go.jp/english/safety/info-services/safety-information/0001.html

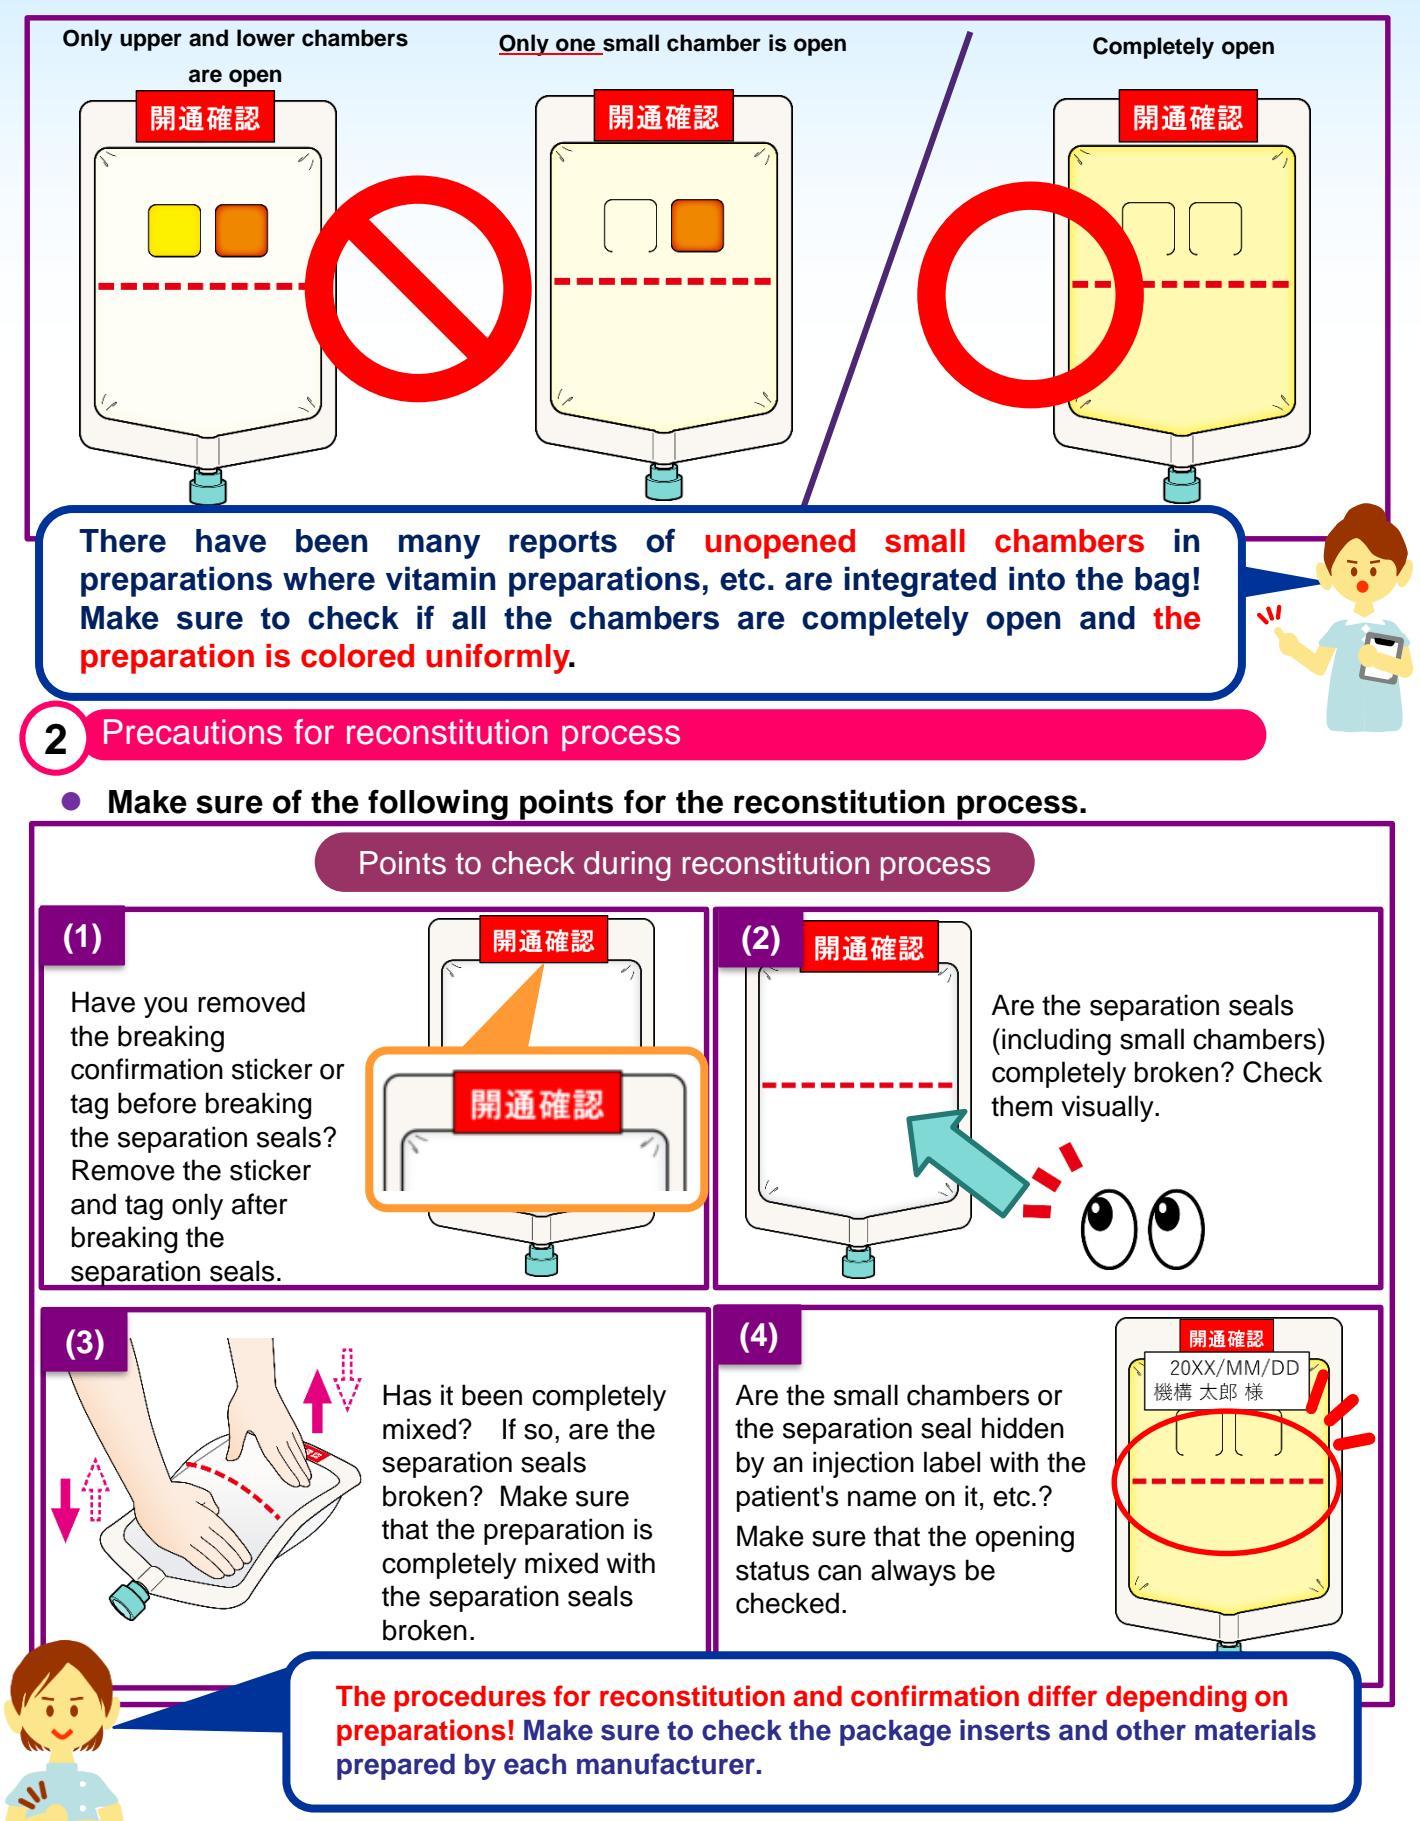
(Case 2) The preparation was administered without breaking the small chambers for the vitamin preparations. When mixing it, there was an assumption that the solution in small chambers for the vitamins would gradually flow out after the start of administration even if they were not opened manually.

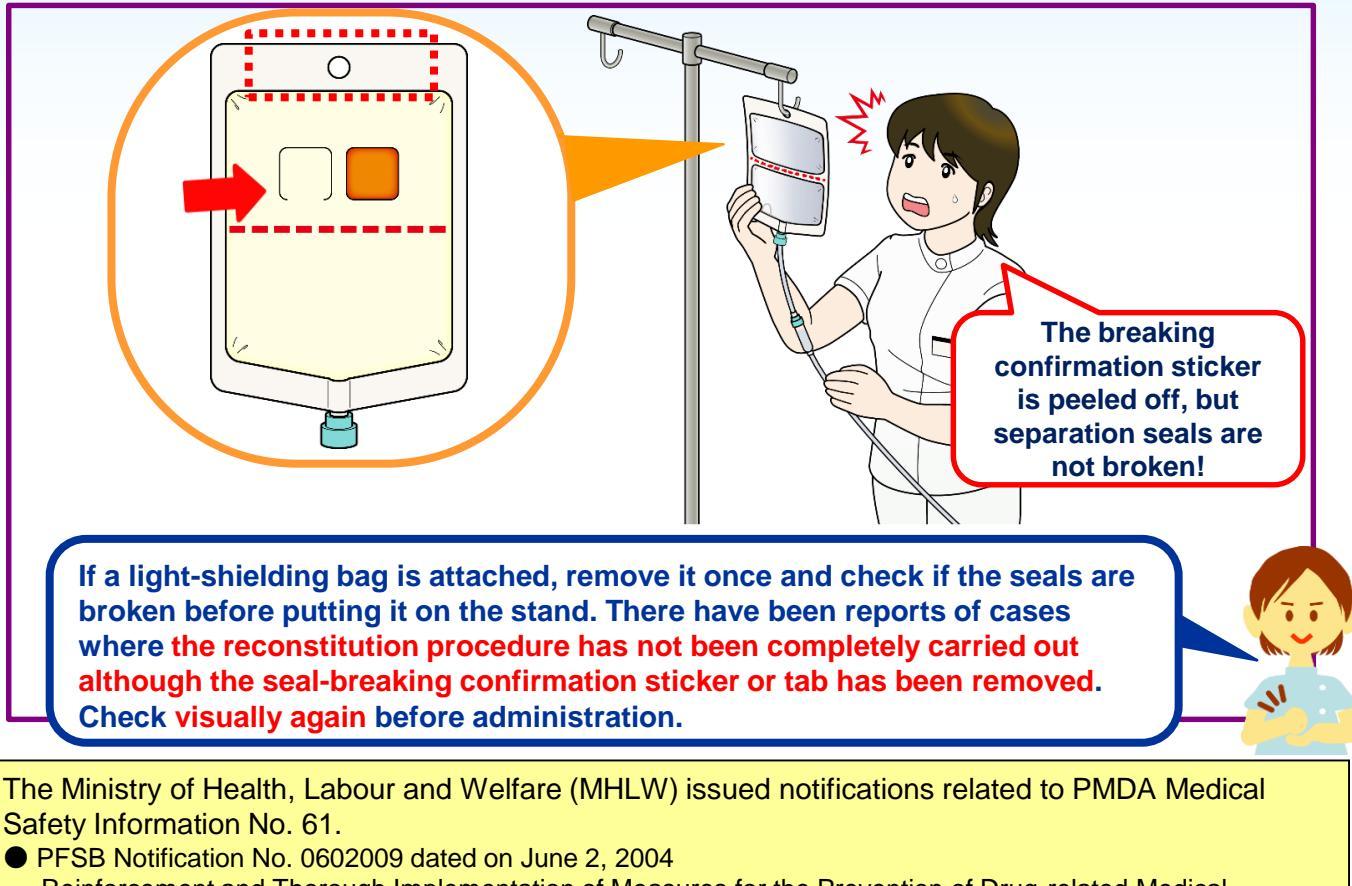
- (Case 3) Because the opening confirmation sticker of the infusion preparation had been peeled off, the medical staff took it for granted that the separation seals had been broken, and they administered it without checking visually.
  - Before administering, make sure once again that all the separation seals are broken.

## Precautions before administration
